# PHASE IV REPORT

### RESULTS AND INTERPRETATION OF DRILLED-IN PILE TEST PROGRAM

EXISTING LOCKS AND DAM NO. 26  
MISSISSIPPI RIVER, ALTON, ILLINOIS

Woodward-Clyde Consultants  
Chicago, Illinois

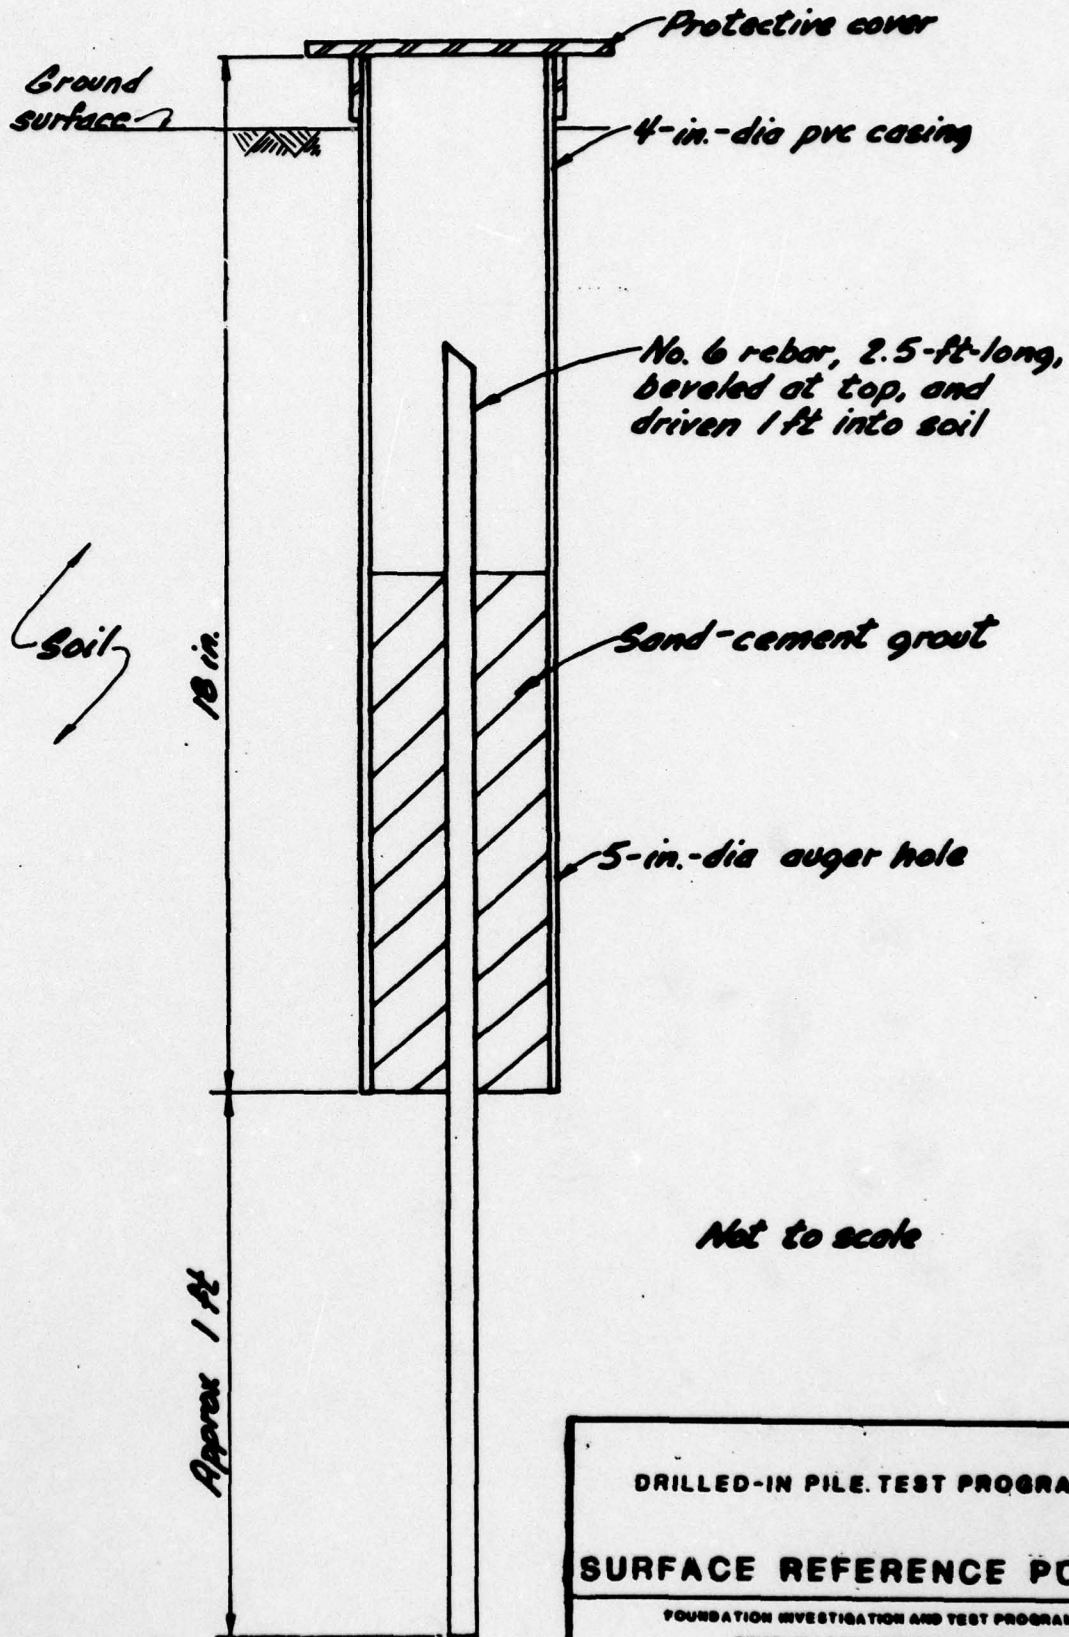
Woodward-Clyde Consultants VTCB26 Phase III</p>	<p><b>Fig. 4.4</b></p>

<p>DRILLED-IN PILE TEST PROGRAM</p>	
<p><b>SURFACE REFERENCE POINT</b></p>	
<p>FOUNDATION INVESTIGATION AND TEST PROGRAM EXISTING LOCKS AND DAM NO. 26 ST LOUIS DISTRICT, CORPS OF ENGINEERS. DACW43-78-C-0003</p>	
<p>

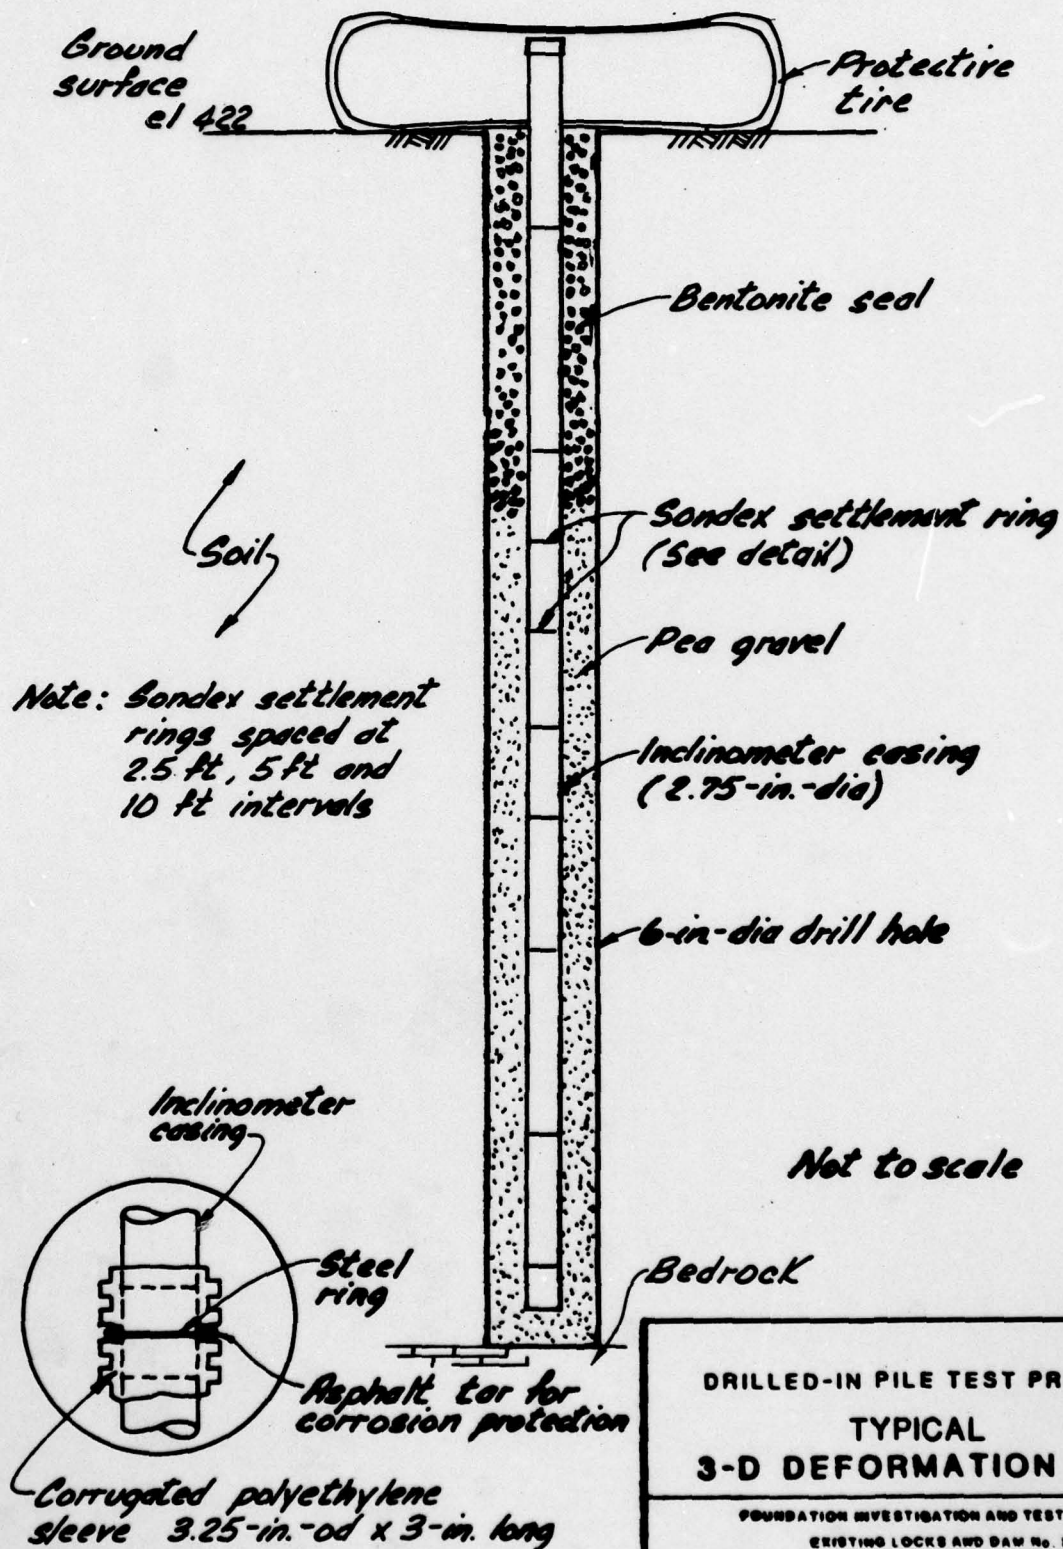
Fig. 4.5

DRILLED-IN PILE TEST PROGRAM  
TYPICAL  
3-D DEFORMATION GAGE

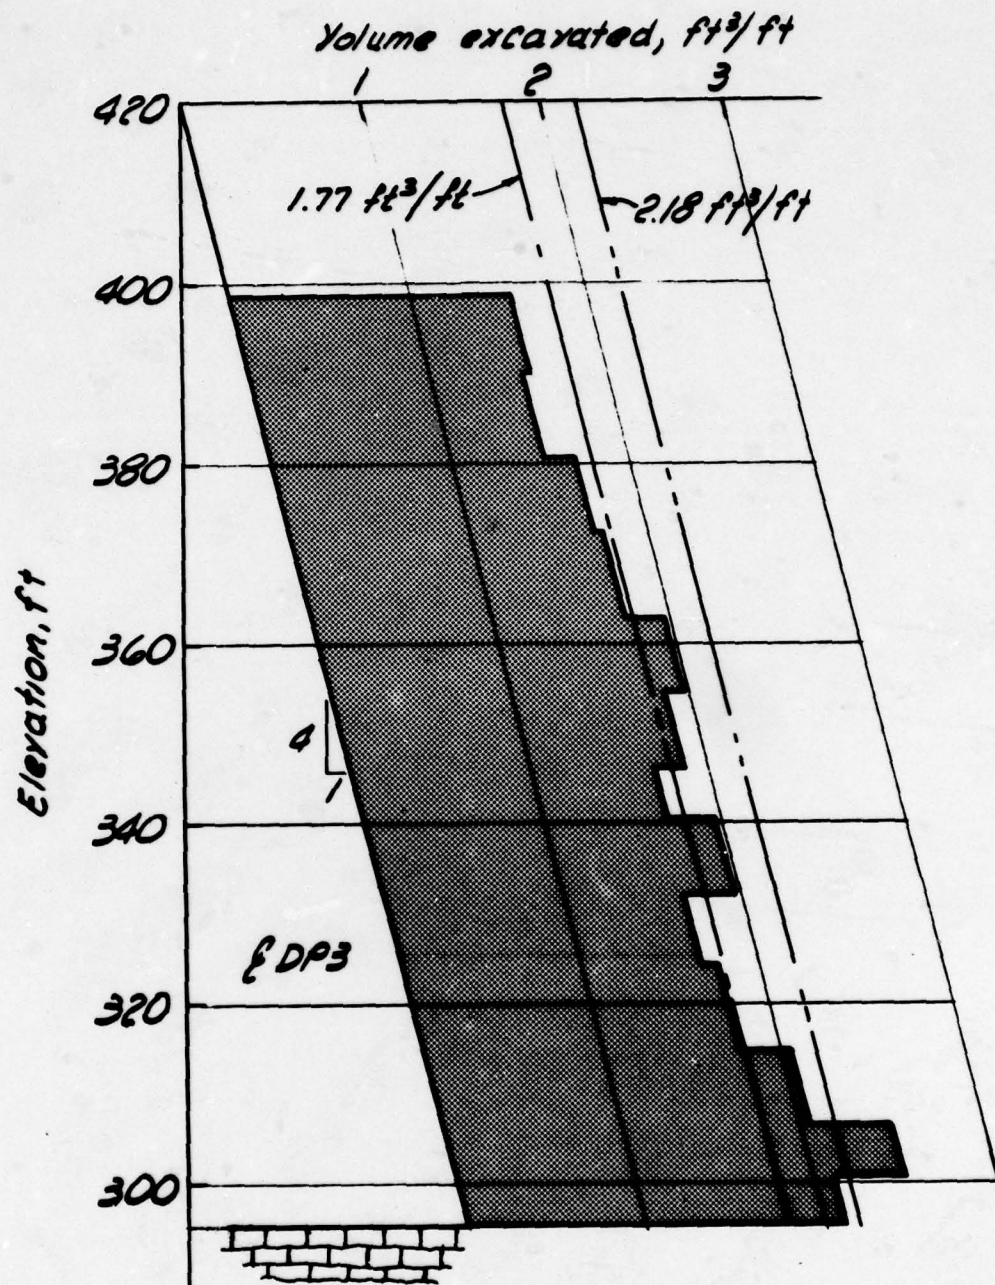
- Legend**
- Measured volume of excavated material
  - Theoretical volume/ft for 20-in.-dia. hole
  - Theoretical volume/ft for 18-in.-dia. hole

DRILLED-IN PILE TEST PROGRAM	
QUANTITY OF MEASUREMENT OF SOIL EXCAVATED PILE DP3	
FOUNDATION INVESTIGATION AND TEST PROGRAM EXISTING LOCKS AND DAM No. 26 ST LOUIS DISTRICT, CORPS OF ENGINEERS. DACW48-70-2-0000	
Woodward-Clyde Consultants 770325 Phase III	Fig. 5.2

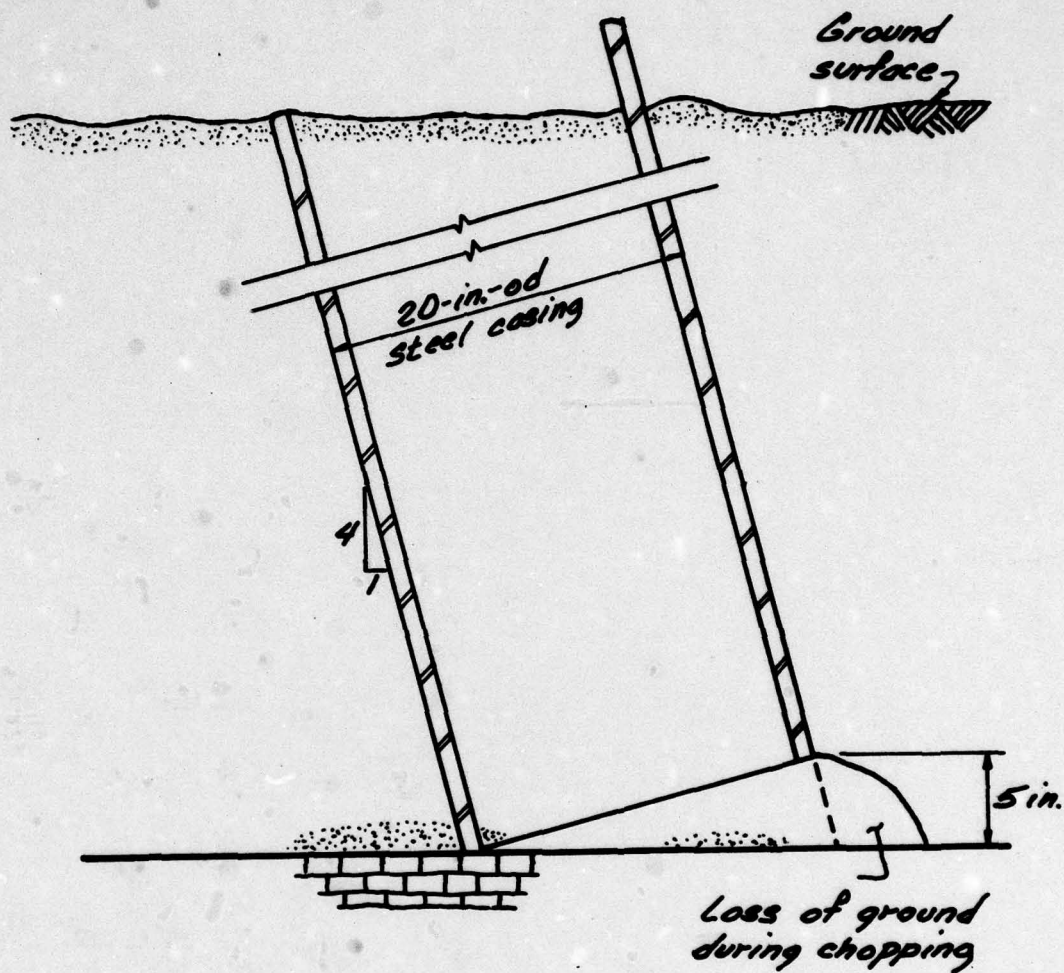
**Fig. 5.3**

**POSSIBLE MECHANISM  
OF LOSS OF GROUND  
AT ROCK CONTACT**

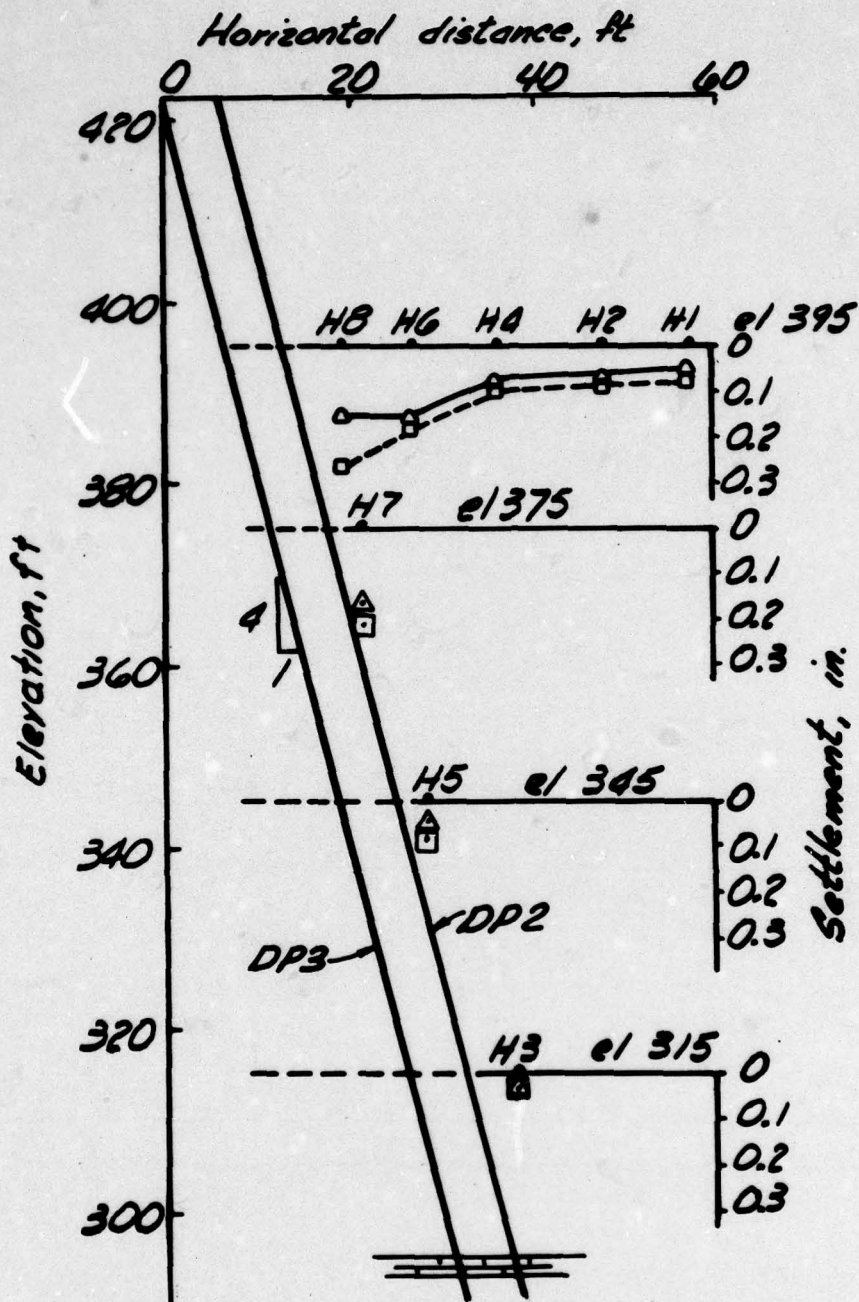
- △ Measurements made at the end of DP-2
- Measurements made at the end of DP-3

<b>DRILLED-IN FILE TEST PROGRAM</b>	
<b>SETTLEMENT PROFILE ALONG DRILLING AXIS</b>	
<small>FOUNDATION INVESTIGATION AND TEST PROGRAM EXISTING LOCKS AND DAM NO. 20 ST. LOUIS DISTRICT, CORPS OF ENGINEERS. D-60015-70-5-0001</small>	
Woodward-Clyde Consultants <small>VT6026 Photo III</small>	<b>Fig. 5.6</b>

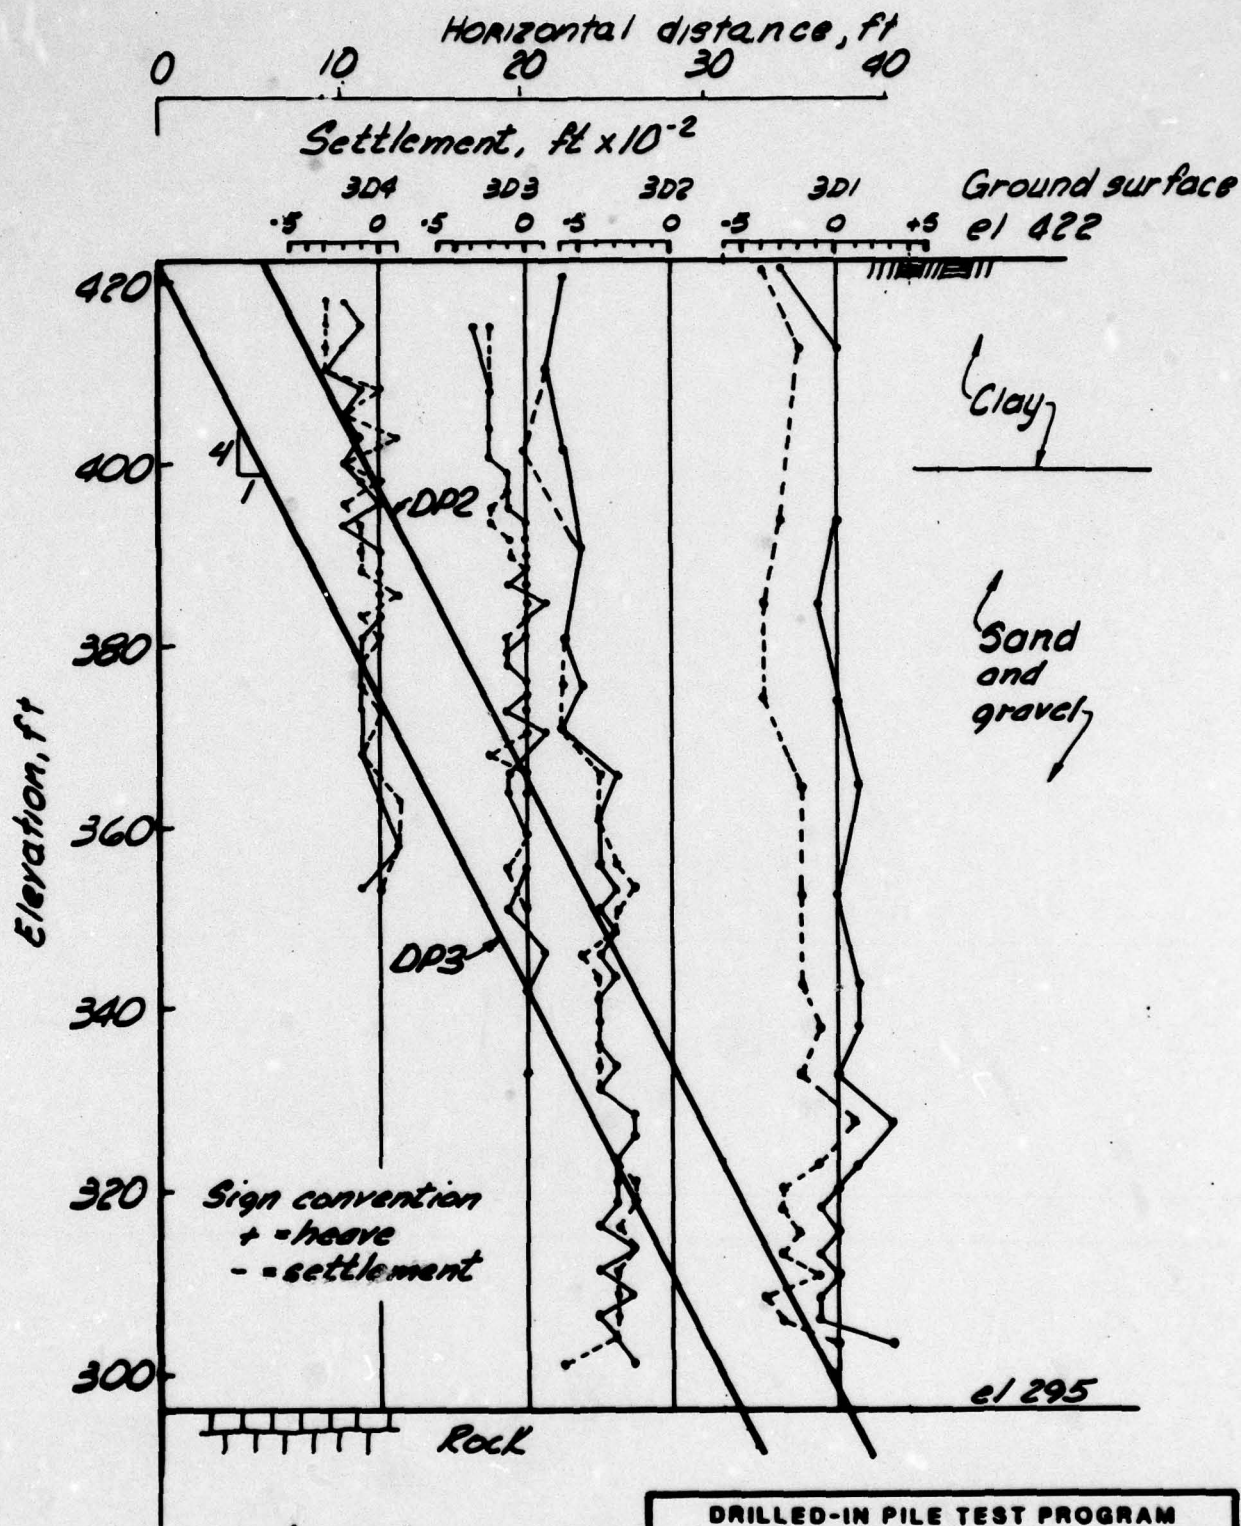
- Legend**
- Measurements made at the end of DP-2
- Measurements made at the end of DP-3
- Notes:**
- (1) Settlement referenced to 21 Dec. 1978 measurements
- (2) Horizontal scale = 2x vertical scale

<b>DRILLED-IN PILE TEST PROGRAM</b> <b>NET GROUND SETTLEMENT</b> <b>AS MEASURED</b> <b>BY SONDEX GAGES</b> <b>3D-1 THROUGH 3D-4</b>	
FOUNDATION INVESTIGATION AND TEST PROGRAM EXISTING LOCKS AND DAM No. 26 ST LOUIS DISTRICT, CORPS OF ENGINEERS. DACW33-78-C-0000	
Woodward-Clyde Consultants VTC025 PHOTO III	<b>Fig. 5.7</b>

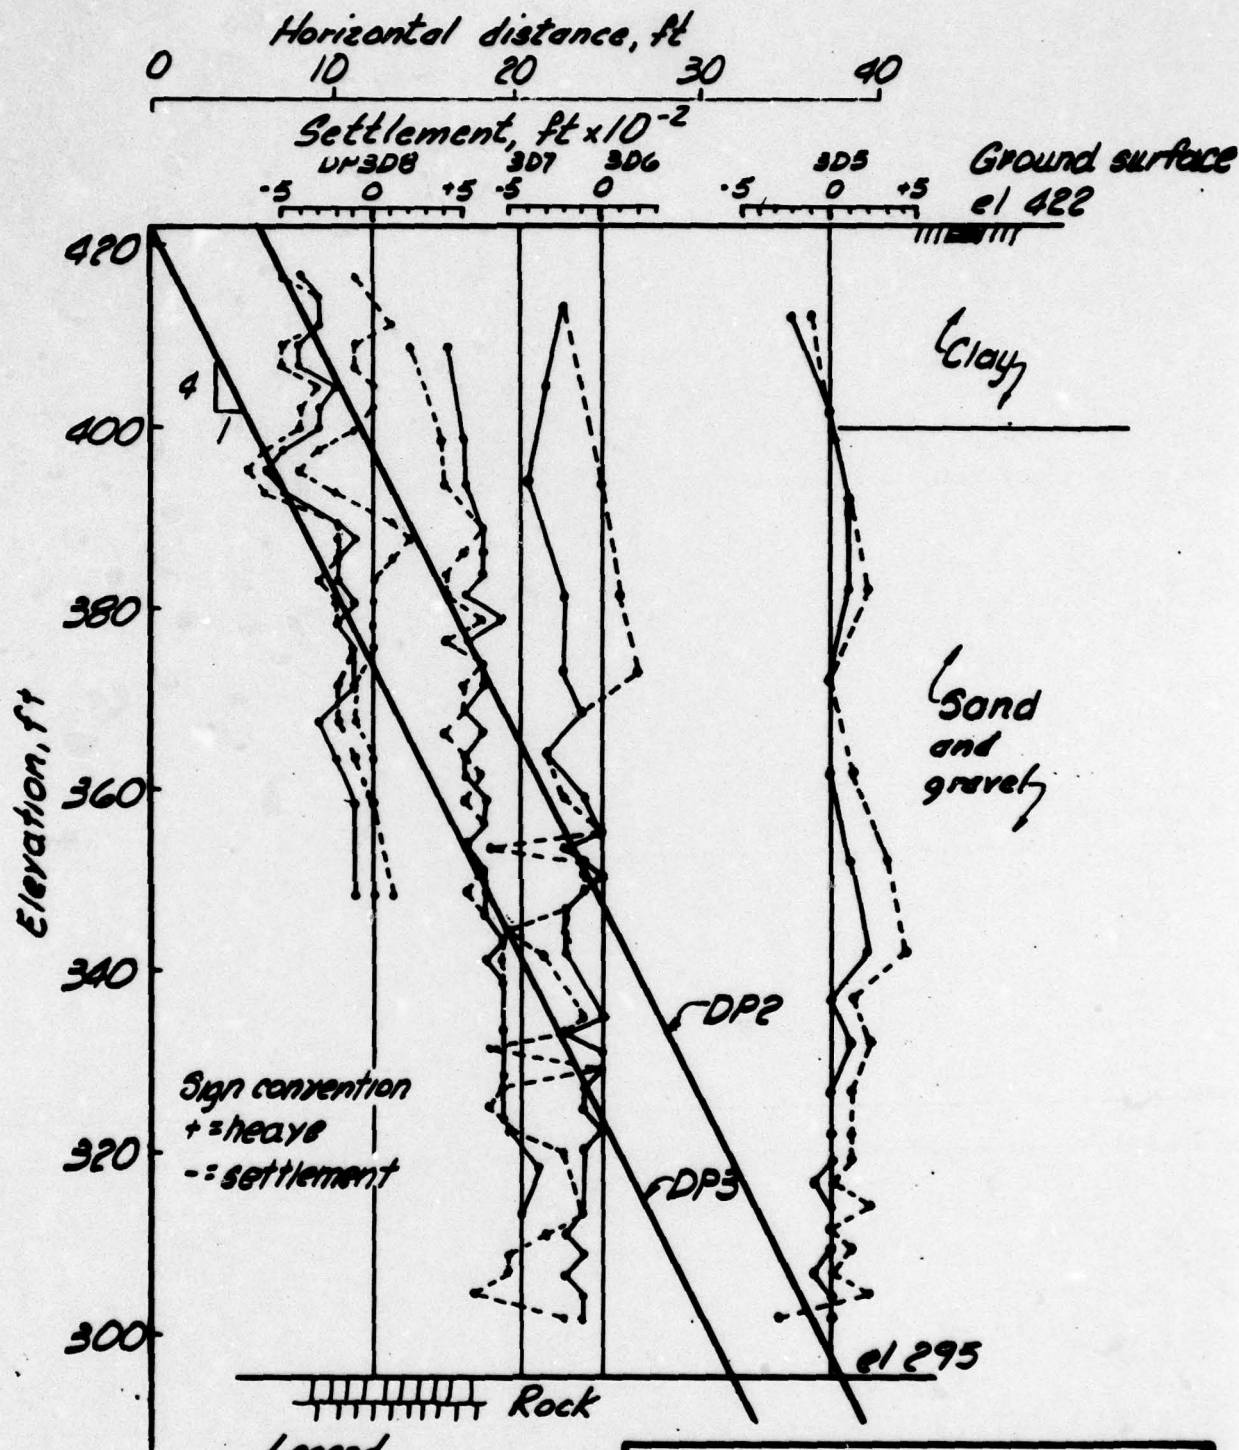
- Notes:
- (1) Settlement referenced to 21 Dec 1978 measurements
  - (2) Horizontal scale = 2 x vertical scale

<b>DRILLED-IN PILE TEST PROGRAM</b> <b>NET GROUND SETTLEMENT</b> <b>AS MEASURED</b> <b>BY SONDEX GAGES</b> <b>3D-5 THROUGH 3D-8</b>	
<small>FOUNDATION INVESTIGATION AND TEST PROGRAM  EXISTING LOCKS AND DAM NO. 20  ST. LOUIS DISTRICT, CORPS OF ENGINEERS.  DAGW43-78-G-0002</small>	
Woodward-Clyde Consultants <small>VT0225 Phase III</small>	<b>Fig. 5.8</b>

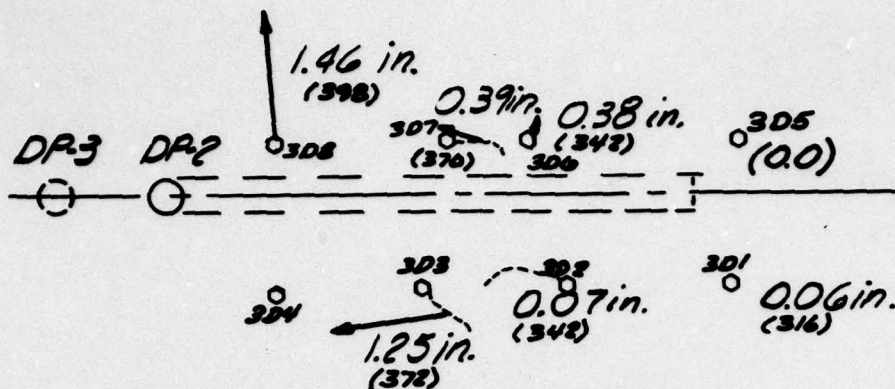
*Maximum horizontal ground deformation  
after DP-2*

<b>DRILLED-IN FILE TEST PROGRAM</b>	
<b>MAXIMUM HORIZONTAL GROUND DEFORMATION</b>	
FOUNDATION INVESTIGATION AND TEST PROGRAM EXISTING LOCKS AND DAM No. 26 ST. LOUIS DISTRICT, CORPS OF ENGINEERS. DACW43-78-C-0003	
<b>Woodward-Clyde Consultants</b> VTCS25 Phase III	<b>Fig. 5.9</b>

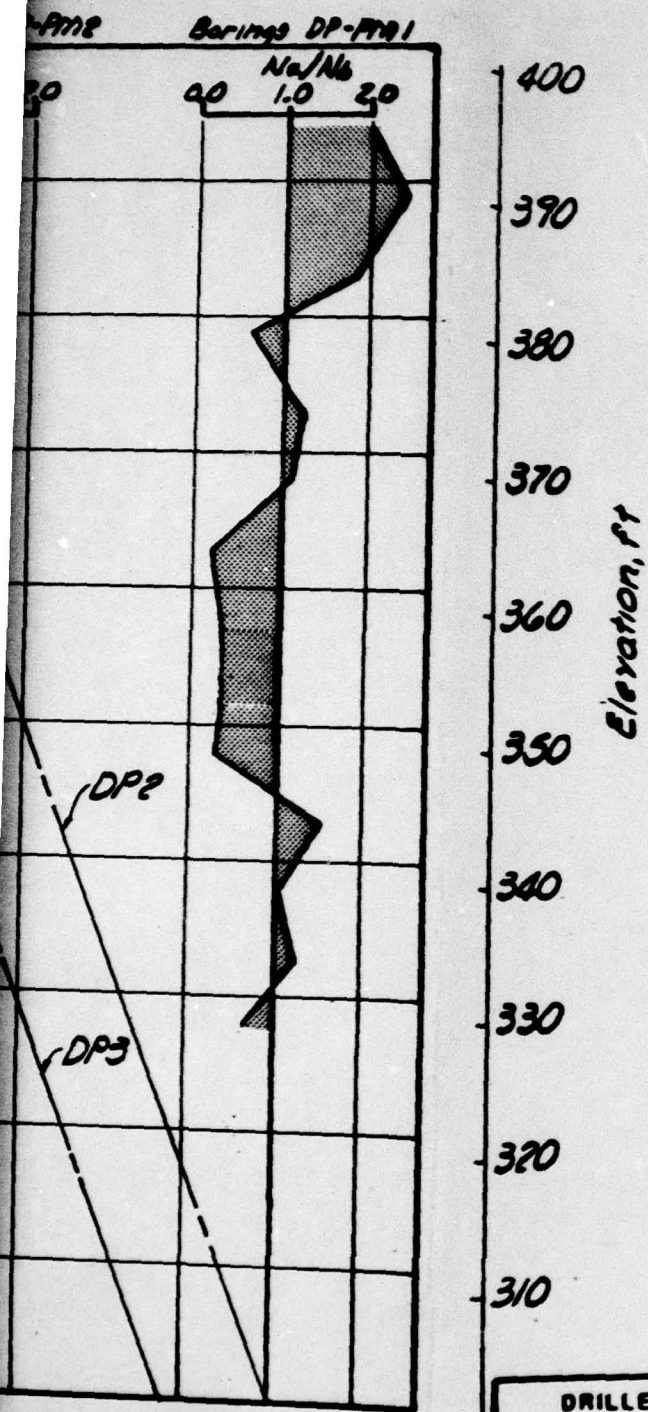
**DRILLED-IN PILE TEST PROGRAM**  
**COMPARISON BETWEEN**  
**STANDARD PENETRATION**  
**RESISTANCES BEFORE AND**  
**AFTER PILE INSTALLATION**

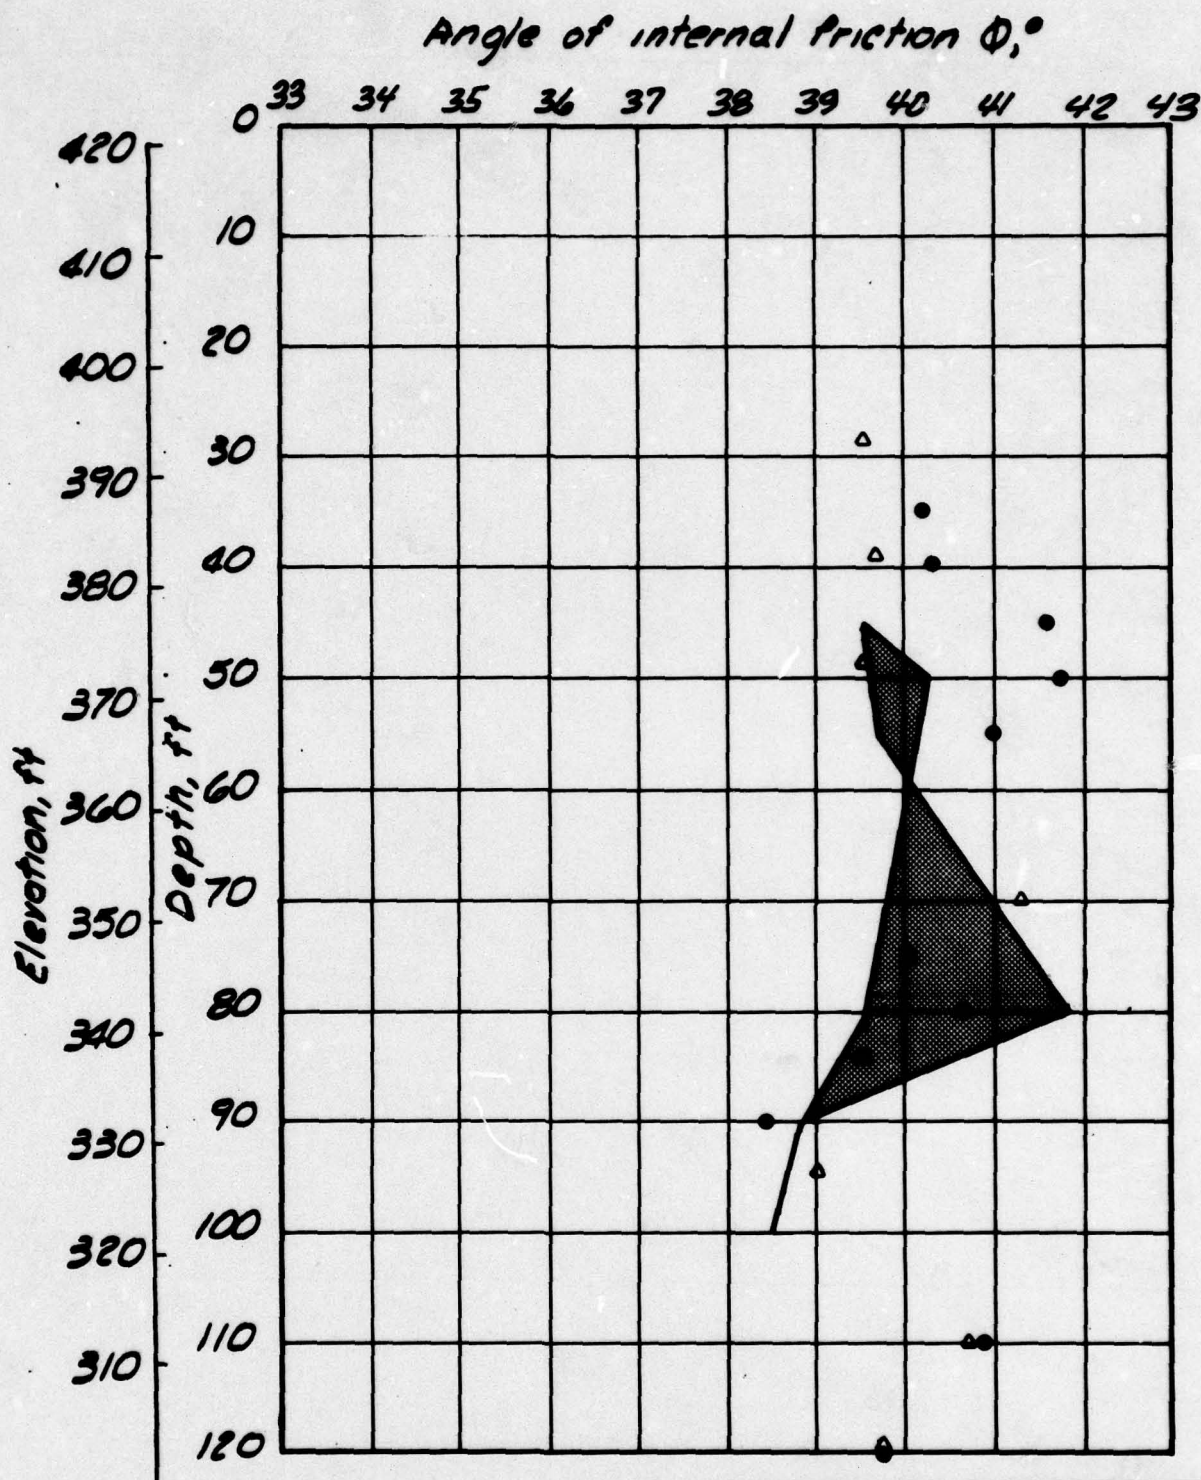
**DRILLED-IN PILE TEST PROGRAM  
COMPARISON BETWEEN ANGLE  
OF INTERNAL FRICTION  
BEFORE AND AFTER  
PILE INSTALLATION**

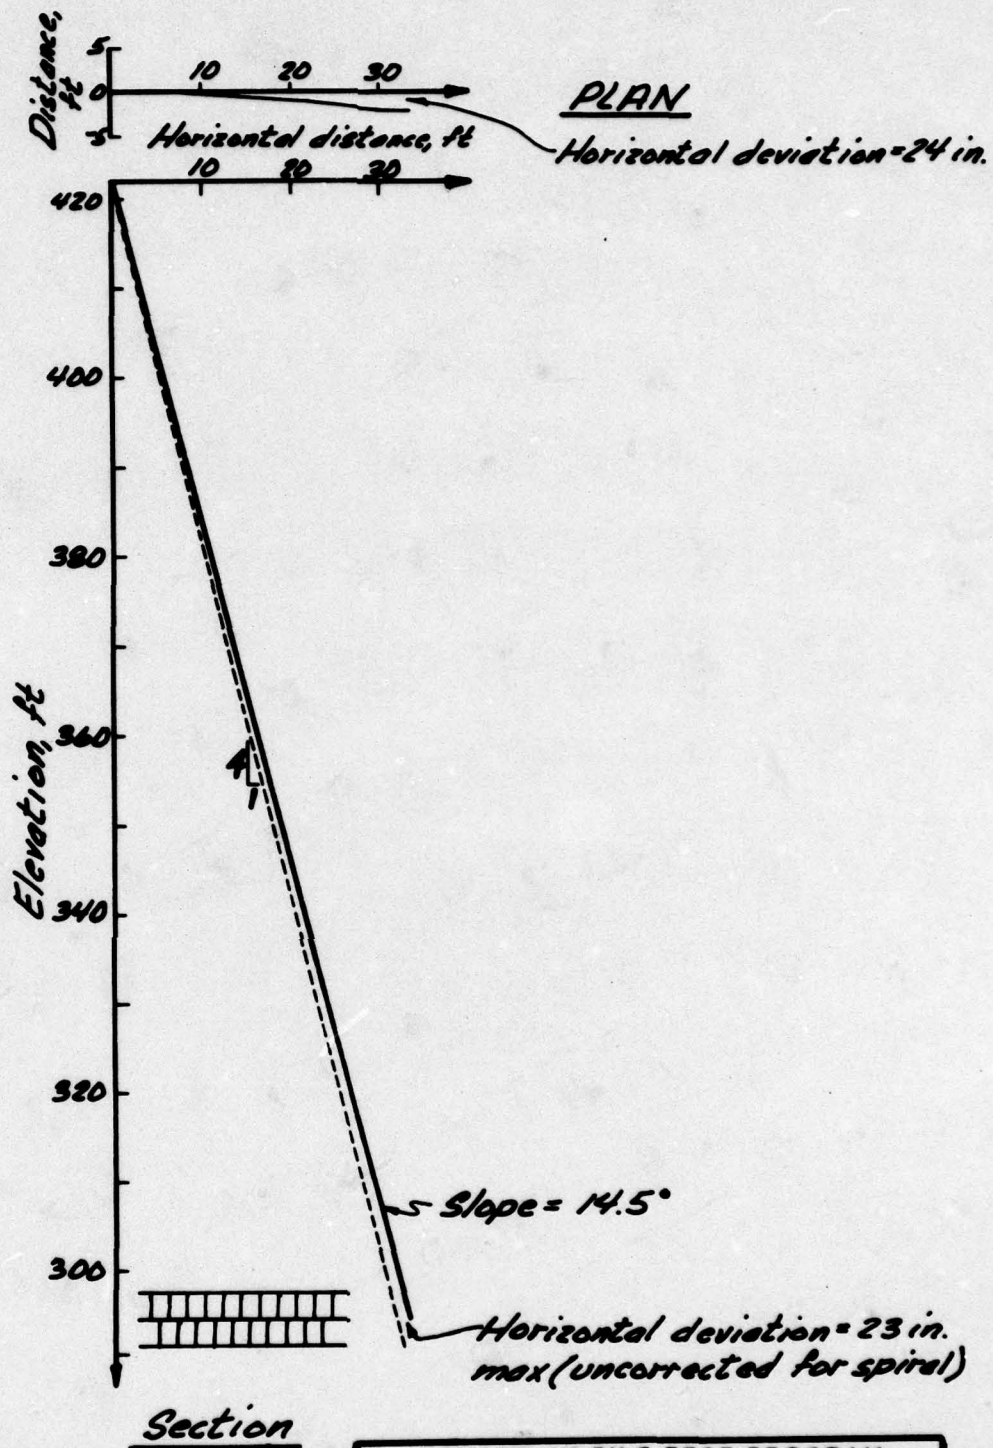
<b>DRILLED-IN PILE TEST PROGRAM</b>	
<b>AS-BUILT ALIGNMENT OF PILE DP-1</b>	
FOUNDATION INVESTIGATION AND TEST PROGRAM EXISTING LOCKS AND DAM NO. 20 ST. LOUIS DISTRICT, CORPS OF ENGINEERS. DACE43-76-C-0005	
Woodward-Clyde Consultants VTC025 Photo E	<b>Fig. 6.1</b>
